Manhole Inspection Summary

Manhole # S19A1_019MH

Insp Date: **5/30/08 12:30 PM**

Location Address: **2101 toley st**

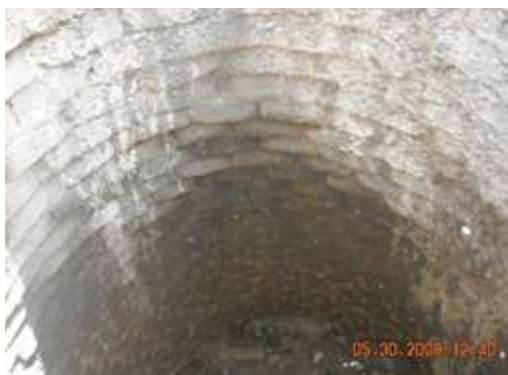
Defect 4

Corbel Material: **Brick** ☐ Parged Type: **Concentric/Eccentric**

Infiltration: ☐ None ☒ **Joint** ☐ Cracks ☐ Mortar ☐ Roots ☒ **Wall**

infiltration @ corbel wall

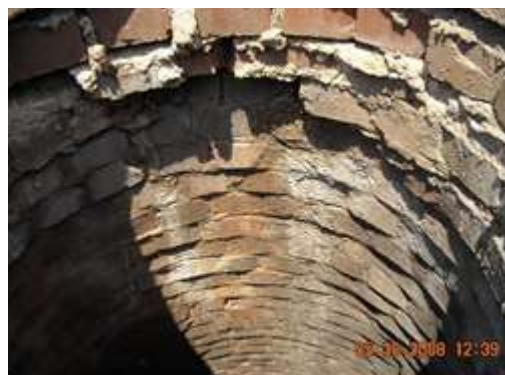
Defect 3

infiltration @ chimney/corbel joint

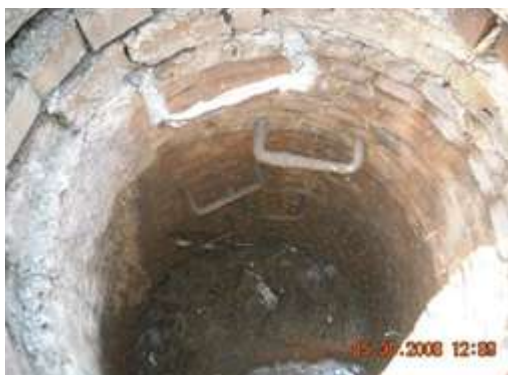
Defect 2

Condition: ☐ Sound ☐ Cracked ☐ Root Intrusion ☒ **Loose Brick** ☐ Deteriorated

Condition: ☐ Sound ☐ Cracked ☐ Root Intrusion ☐ Deteriorated ☐ Leaks ☒ **Debris**

Steps Count: **5** Missing: **0** ☒ **Corroded**

corroded steps, chimney loose bricks,
bench debris

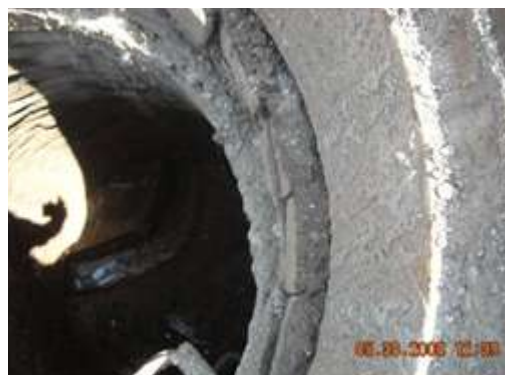
Defect 1

Frame Offset: **1.** (in.) Condition: ☒ Sound ☐ Cracked ☐ Leaks
25

frame offset

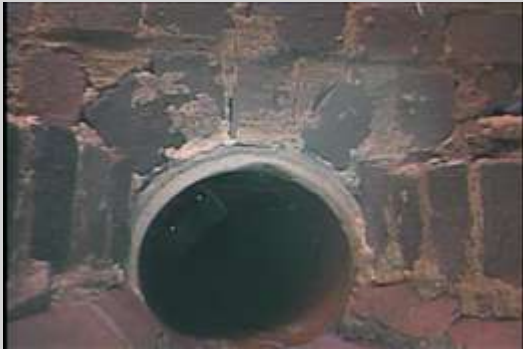
12 O'Clock Outflow

8 in. Circular Gravity Sewer
Pipe Out @ 12 O'Clock

Pipe Height: **8.4** (in.) Rod and Bar (Angled)
Pipe Material: **Clay** ☐ Pipe Lined
Invert Depth: **9.40** (ft.) Flow Characteristics: **Slow**
Deposits: ☒ None ☐ Mud ☐ Sludge ☐ Debris ☐ Grease
Silt Depth: **0** (in.) Deposits Extent:
Infiltration: **None** Pipe Seal Cond: **Sound**

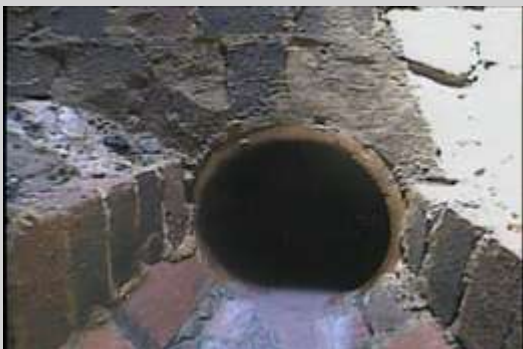
9 O'Clock Inflow

8 in. Circular Gravity Sewer
Pipe In @ 9 O'Clock

Pipe Height: **8.4** (in.) Rod and Bar (Angled)
Pipe Material: **Clay** ☐ Pipe Lined
Invert Depth: **8.90** (ft.) Flow Characteristics: **Slow**
Deposits: ☒ None ☐ Mud ☐ Sludge ☐ Debris ☐ Grease
Silt Depth: **0** (in.) Deposits Extent:
Infiltration: **None** Pipe Seal Cond: **Sound**
